Report of sediment removal experiences, outcomes & future implementation for Neimann Creek

December 2018

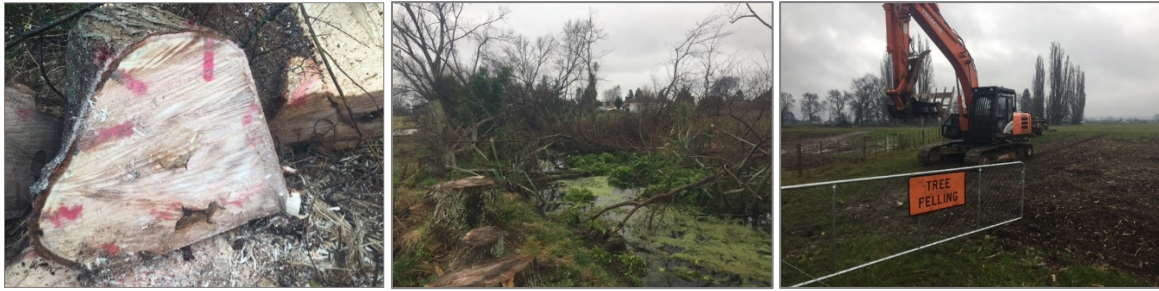
The first stage of restoration was the poisoning and removal of willow and other weeds that were growing along much of the creek. Before restoration work commenced the length of the stage one area of the creek was unable to be navigated by kayak. Fine roots from the willow choked the creek in several places, trapping sediment and impeding water flow. Shortly after the willow were poisoned these fine roots died enabling better water flow and the natural flushing of some fine sediment. It has been reported that poisoning of the willow very quickly led to full navigation of the creek by kayak and more gravels being seen.

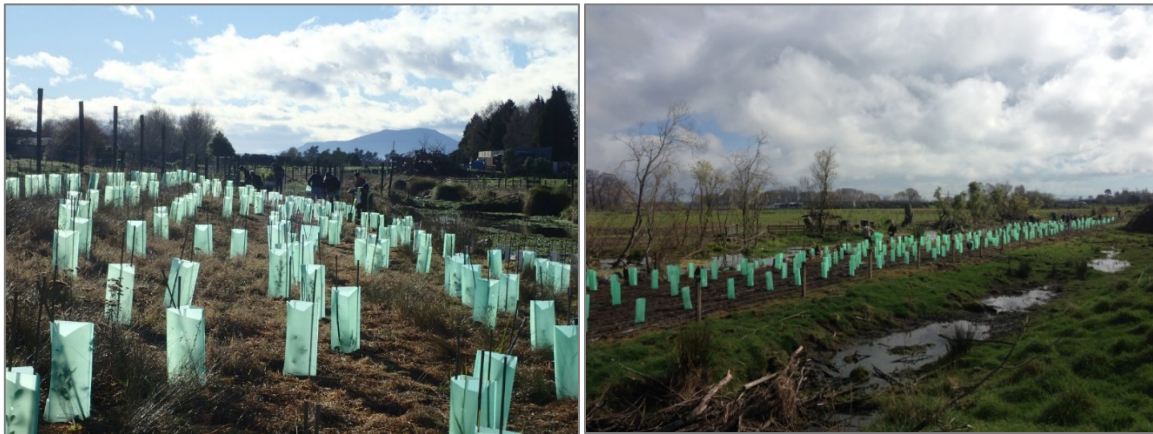
There have been two planting weeks undertaken to achieve the planting targets of stage one of the project. The first was in September 2017 (400 meters planted with 1385 plants) and the second in June 2018 (460 meters planted with 2100 plants). Through these planting days we were able to plant 860 meters of riparian boundary with 3485 plants (up to 8 meters deep where the land owners allowed). This area of the creek is now fenced to protect riparian plantings and to restrict stock access to the creek.

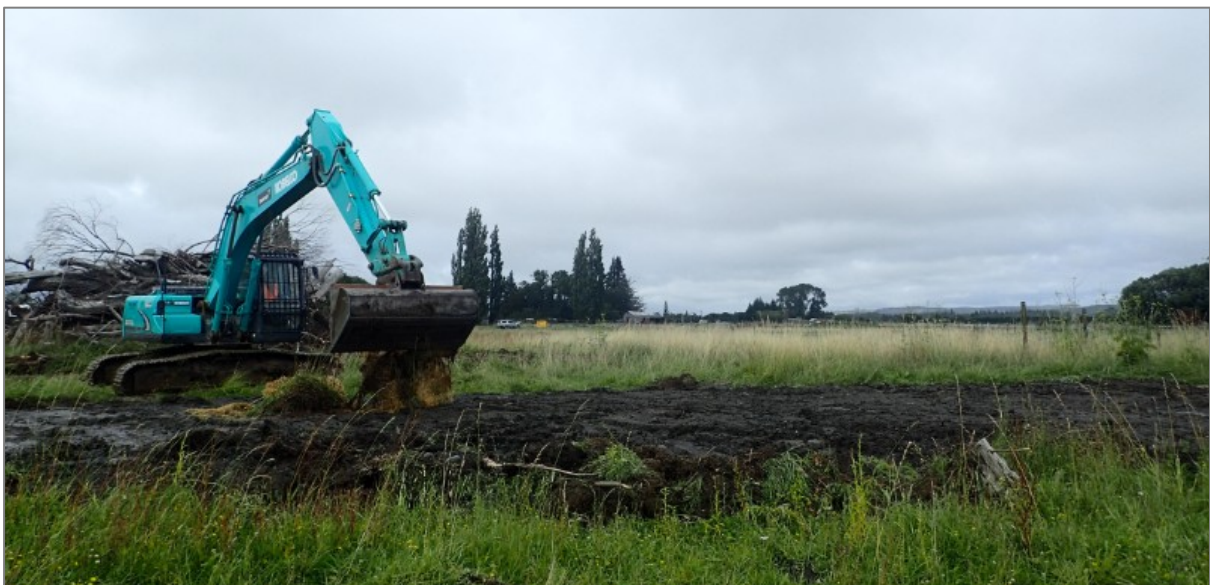
Over 3 days in January 2018 sediment was removed from the source of the main tributary of the creek and down a further 440 meters of the main creek. The process was to have a 20 tonne digger¹ reach out over the existing bank and scoop sediment out of the creek and deposit it on the land behind the digger. The bank of the creek was left undisturbed so that the existing vegetation could form a buffer/filter for water laden sediment draining out of the removed sediment and back into the creek.

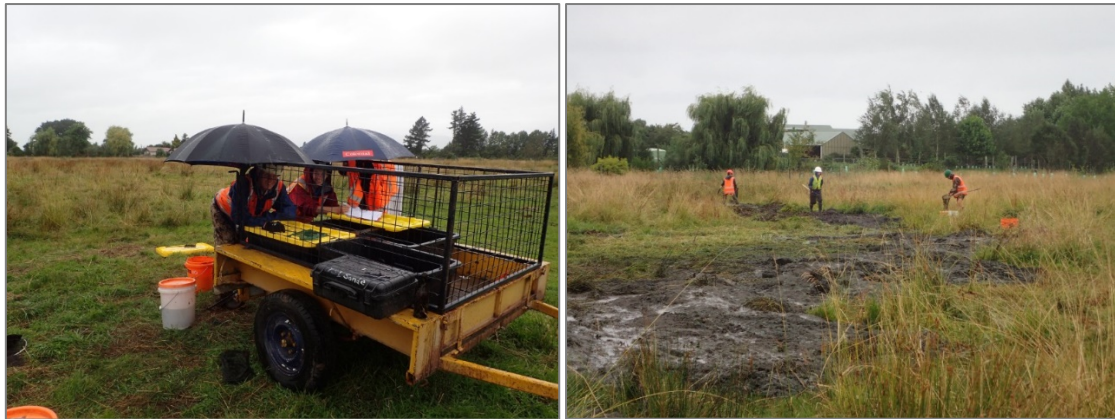
This sediment was then sorted through and any eels or other fish in the sediment were captured, counted, measured and released back into the creek up stream or relocated to other suitable local streams. This process was managed and overseen by an Ecologist.

After a period of draining and fish recovery the sediment was spread more evenly over the adjacent paddocks. On the final day straw bales, which had been used as sediment control, were spread over the removed sediment in the paddock to disperse forecast heavy rain and stabilise the now dried sediment.

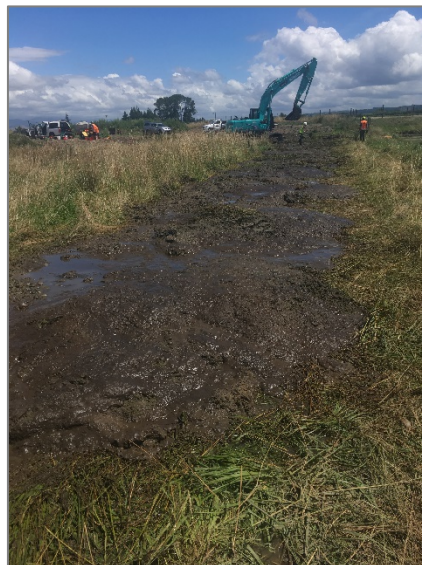
We estimate that at least 70-80m³ of sediment (dried) was removed from 440 meters of the Creek.

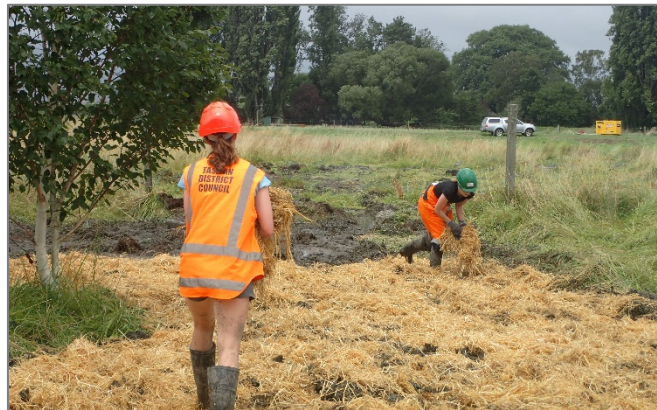
The original plan was to remove sediment from only 200 meters of the creek. The decision to continue beyond the initial 200m metre area was made to maximise the utilisation of the resources and

knowledge we had on site at the time and the resource consent for the work and to test the methodology across a variety of depths of sediment and different geography of the creek².

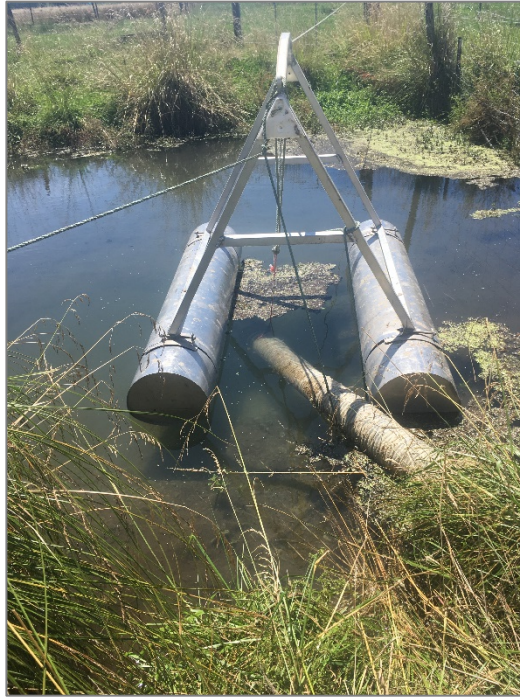
It is worth noting that the digger method we used relied on several key things to be successful. The digger operator we used was very experienced in both this method of sediment removal and in working with the ecologist we had on site. The site we were using had excellent accessibility for the digger to access the creek and for the removed sediment to be spread over the adjacent paddocks. Sediment was spread the entire length of the area of sediment removal and was up to 5 metres wide. Sediment control with the 6 inch pump was also successful when the water was deep enough for it to be suspended over a pontoon. But it did result in the flooding of several paddocks.

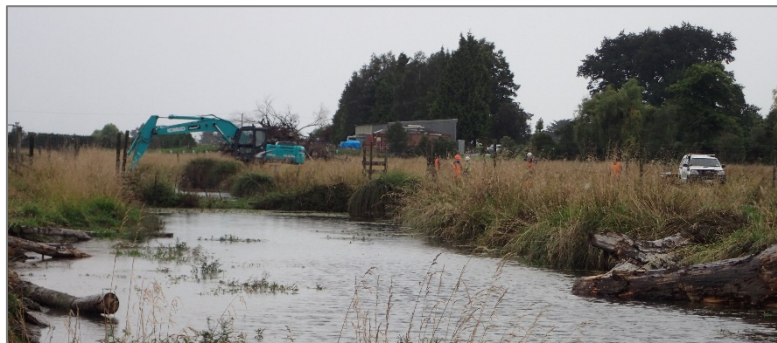
Several sediment control methods were used including pumping sediment laden water to land, straw bale fences and sediment cloth fences, as well as maintaining an undisturbed creek edge. Each of these had varying levels of ease of installation, cost and effectiveness. But at all times we remained within the parameters of our resource consent.

- The placement of sediment controls should be planned and ideally installed in the days prior to sediment removal work commencing
- Use of several sediment control mechanisms is beneficial i.e. hay bales up stream followed by a silt fence will allow the hay to capture silt and weed and debris that could undermine a silt fence alone.

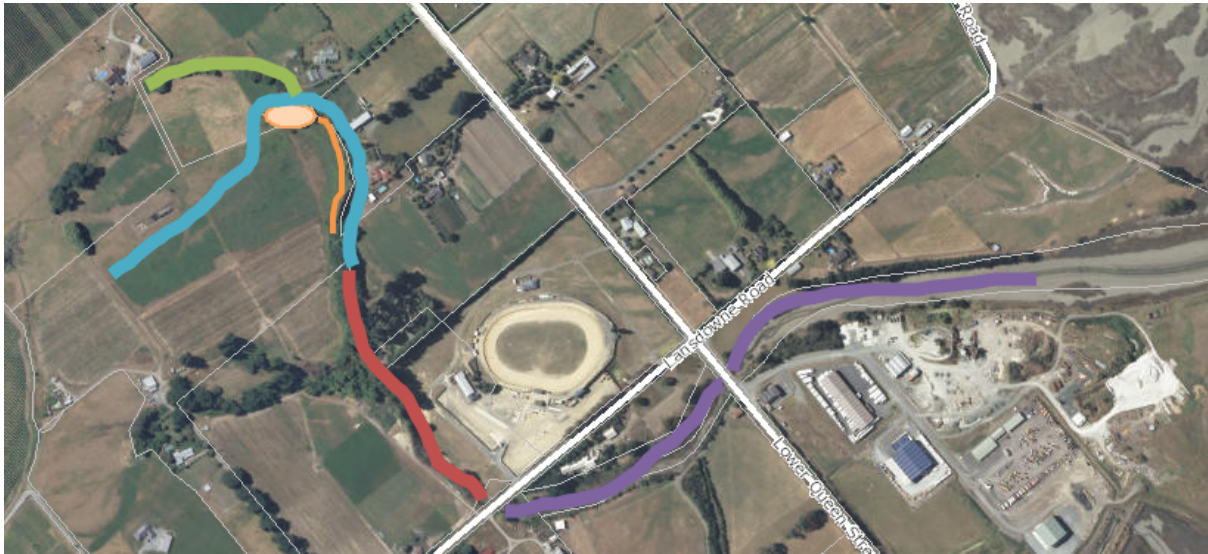
Stage two restoration of Neimann Creek (indicated in green) is underway with funding from the Department of Conservation Community Fund. This stage will remove willow and weeds, plant and fence the northern tributary of the creek and maintain the plantings undertaken in stage one (blue). There is no sediment removal planned for stage two due to the narrow and low flow of water in the northern tributary and the lack of access to staging areas alongside of the creek. It is anticipated that the willow removal will significantly improve the flow of the tributary allowing some natural reduction of sediment.

Funding for further planting is being sought for stage three (orange). The area indicated in red is not able to be accessed for the project. Both landowners adjacent to the creek in this area do not wish to participate in this project. We remain hopeful that overtime this may change. The area indicated in purple is stage 4. This area is not suitable for sediment removal due to its tidal nature, but would benefit from planting and weed removal and management.
